EFRATOM Model FRS-C 10MHz Rubidium Clock.

Model FRS-C

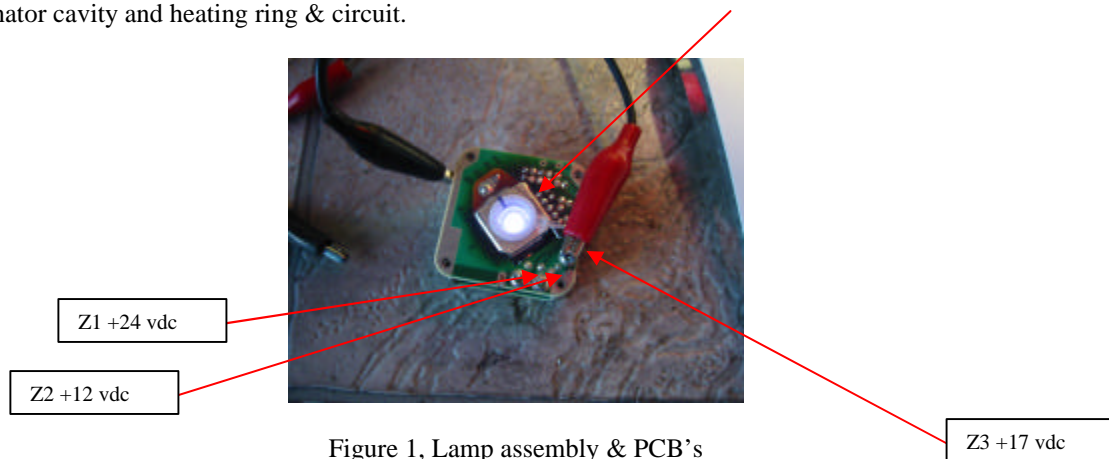
Figure 1, Lamp assembly & PCB's

The Rubidium (Rb) lamp does not have a filament. The function of the lamp assembly is to generate the right Rb Spectral lines \sim (768nm). Rb light (Plasma) is generated as a result of a 80~100 MHz oscillator and heat generated from the lamp support housing.

Figure 1 above shows the lamp ignited as a result of +24 vdc on pin Z3 as shown, the photo shows a blueish discharge. Once ignited, cut back the Z3 voltage to +17 vdc.

Next add +12 vdc to Z2 and then +24vdc to Z1. The current consumption on the +24vdc rail should be approx. 400mA. After about 2 minutes when the housing is temperature stabilized to approx. 84 degrees C, the following should be observed:-

- The current drops to approx. 200mA
- The Plasma discharge colour has an added purple haze around the outside, indicating proper Rb vapour pressure in the lamp envelope.

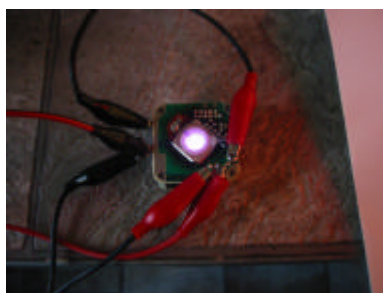
Figure 2, proper Rb ignition

Proper ignition and the right housing temperature with maintain the correct Rb vapor pressure resulting in an added purple hazy ring within the lamp and the surrounding Teflon support insulator.

Figure 2 shows the added purple haze, it is important now to check the housing operating temperature. Although the manual states 106°C, in fact 106°C is the temp within the lamp. The emitted light is a combined result of Plasma discharge and heat.
